Damage Analysis of Structural Flexible Pavement in Towua Road Link in Palu City

Syamsul Arifin

ABSTRACT: Based on the results of the preliminary survey conducted along Towua roads there are some and the stock as exfoliation layers the surface of , the release of grains , split open and crack. So as to cause a lack of security and comfort for road users. The purpose of the study to identify a kind of , the level of , and the percentage of road damage priority value on roads towua and the factors causing the damage occurs and apply the method or the treatment of defects that occurred on Towua roads.

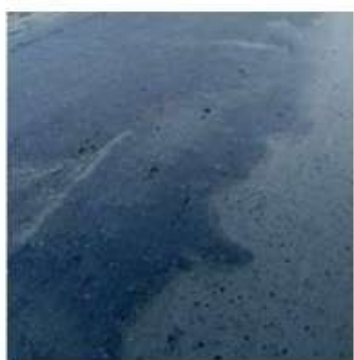
Figure 2.1. Sta: 0 + 50 (Bleeding)

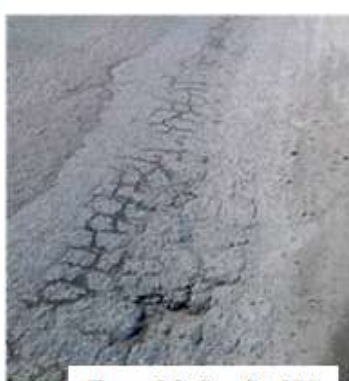
Figure 2.2. Sta: 0 + 300
(Alligator Cracking)

Based on the results of the survey and identification of damage to the road that has been processed, the percentage of roads that experienced overall crack damage along JalanTowua was 9,415%. The cracks that occur have a gap of 3-7 mm. The length of the cracks ranges from 4.18 to 76.32 m, with a width of 0.83 m to 1.12 m.

Asphalt content that is not according to the specifications specified, shows that the asphalt and aggregate mixture is not good or the bond strength between asphalt and aggregate is not good. For gradations that are not included in the specifications, it is likely that the required technical properties cannot be met, one of which may occur when mixing material in the AMP (Asphalt Mixing Plan) which is not good and results in easy cracking in the pavement layer of JalanTowua. In addition, crack damage is also caused by the repetition of traffic loads that have exceeded the load capacity limit that can be borne by the surface layer, and due to dynamic loading that is repetitive loading due to fatigue in the material, so that in the end it will reduce the strength of the layer these surfaces.

- a). For surface peeling damage, repairs are done by dismantling and re-coating (added layer overlay) with materials that comply with the applicable technical specifications.
- b). For damage to crocodile skin handling by means of resurfacing the new surface above it includes one-layer asphalt (Burtu), two-layer asphalt (Burda), and thin layer of asphalt (Lataston). Can also be repaired by means of sprinkling hot and compressed aggregates.
- c). For damage to the release of grain handling by means of one-layer asphalt (Burtu), two-layer asphalt (Burda), and thin asphalt concrete (Lataston).

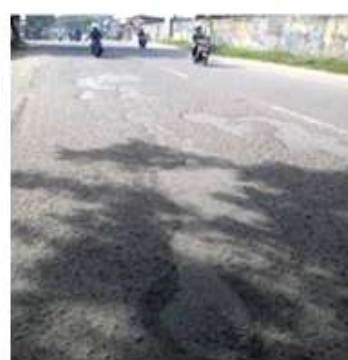
Figure 2.3. Sta: 0 + 500
(Exfoliation of the Surface Layer)

The hole is shaped like a bowl, into the hole until the previous pavement layer. Hole size varies, with lengths of 1.88 m to 53.27 m while the width is between 1.37 to 2.82 m. Based on the results of the survey and identification of damage to the treated road, the percentage of the road that suffered overall surface peeling damage along JalanTowua, Palu, was 21.304%.

Based on field observations, there are several parts of the road that do not have drainage channels, but when it rains, only a small portion of rainwater which is held above the rest of the road flows to the shoulder of the road until it enters people's homes. Although only a small portion of water held above the road surface does

not rule out the possibility that it will affect the pavement layer. As a result, the pavement which contains water will expand and especially on the asphalt layer will result in a lack of adhesion between aggregates and asphalt so that it is easy to experience overlay damage and if it is not repaired soon the damage will develop into a holerepetition combination of traffic loads.
