Slope Stability Assessment of the Aburi Mountain Road-Cut, Eastern Ghana

ABSTRACT

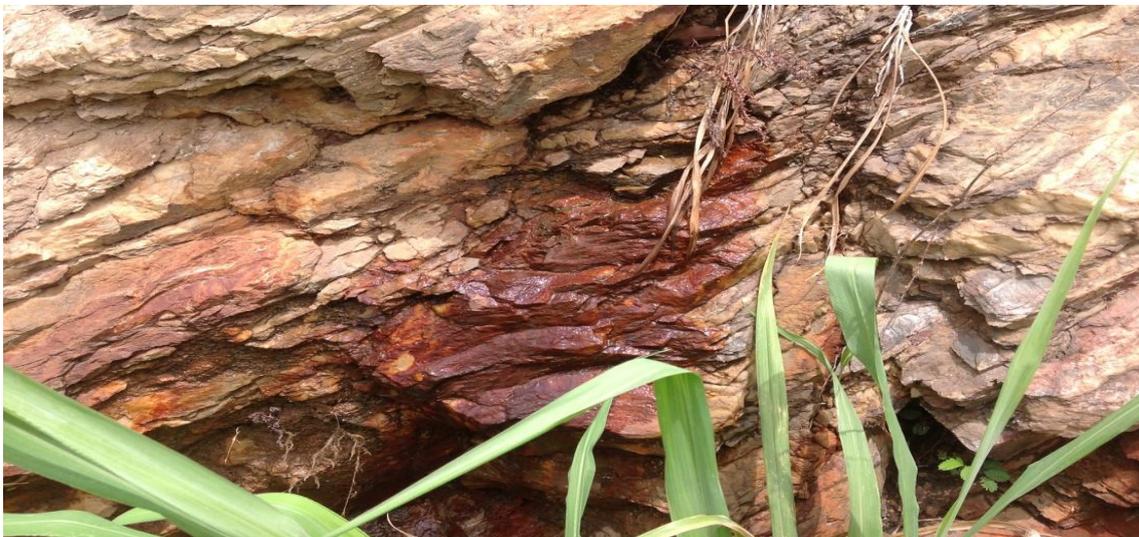
Slopes observed at the study area were moist to wet. At some places, water was seen dripping from the surfaces of the slopes (Figure 1). The water helps to reduce friction between the rocks, making it easier for the rocks to fail. Water in rocks also increases the weathering of rocks, and as a result, the specific gravity of the rocks is reduced, and this goes a long way to reduce the strength of the rocks.

Figure 1: Water dripping from the surface of a rock in the study area

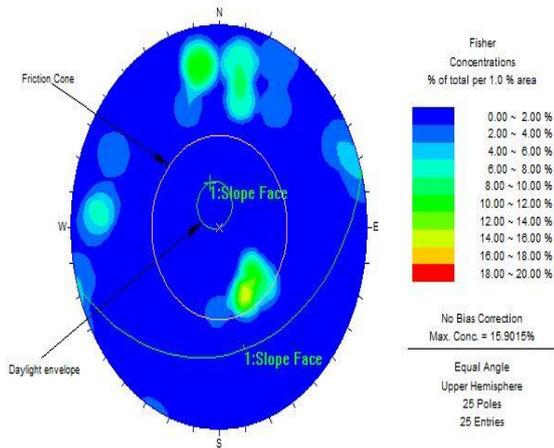
Kinematic analyses indicate that all four windows are susceptible to multiple modes of failure. Planar failure is possible where discontinuities daylight the slope face and fall outside the friction cone (as shown in Figure 4, Figure 5, Figure 6, and Figure 7). Wedge failure is prominent in areas with intersecting joint sets, particularly in Window 4 (Figure 8, Figure 9, Figure 10, and Figure 11). Toppling failure is also likely due to steeply dipping discontinuities oriented unfavorably with respect to the slope (Figure 12, Figure 13, Figure 14, and Figure 15).

Figure 4: Planar analysis for window 1

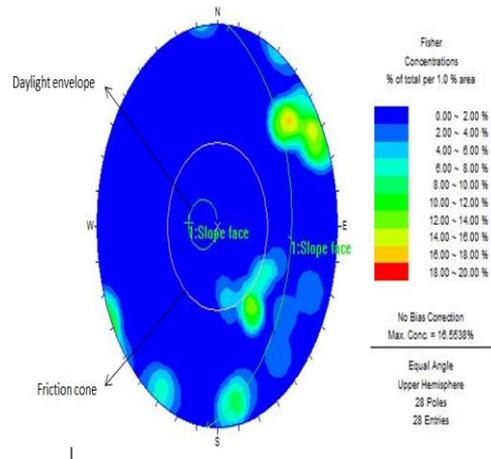
Figure 5: Planar analysis for window 2

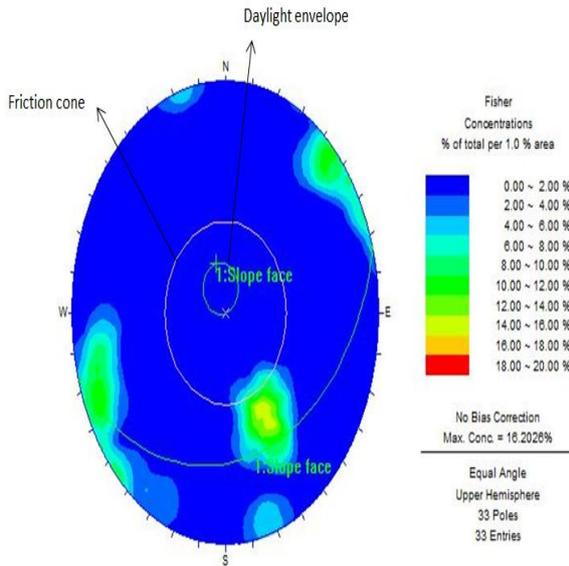
Figure 6: Planar analysis for window 3

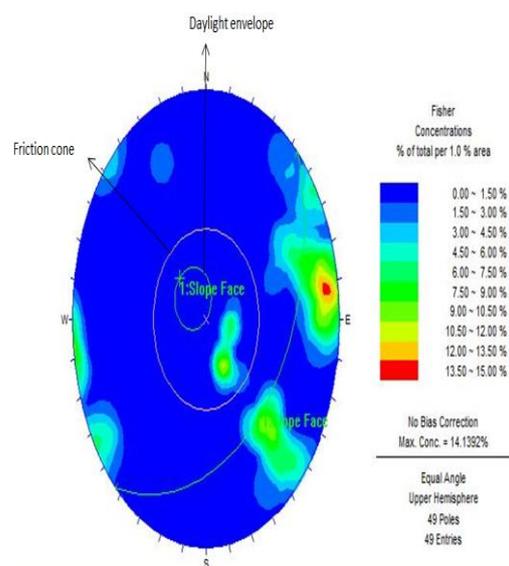
Figure 7: Planar analysis for window 4

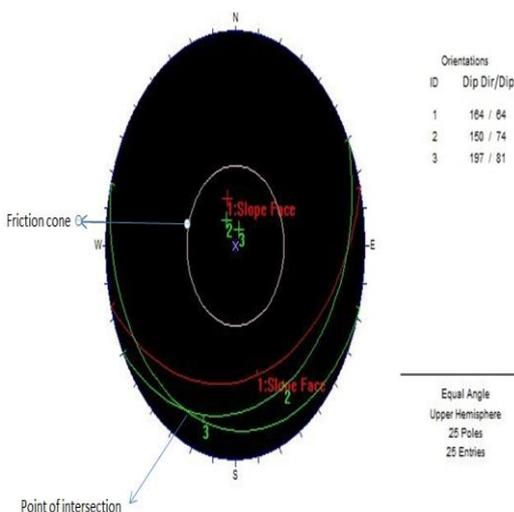
Figure 8: Wedge analysis for window 1

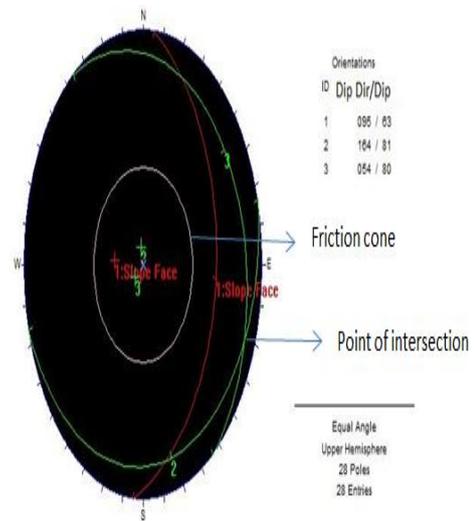
Figure 9: Wedge analysis for window 2

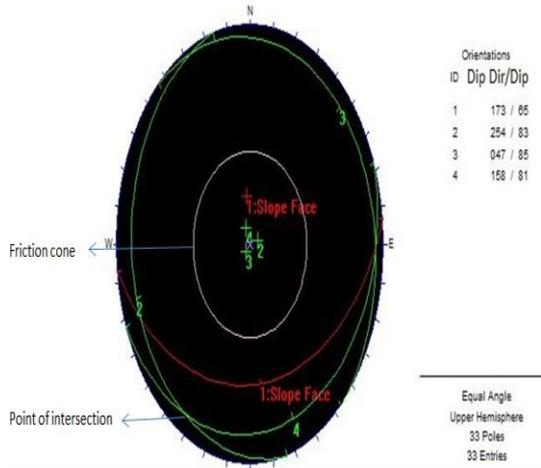
Figure 10: Wedge analysis for window 3

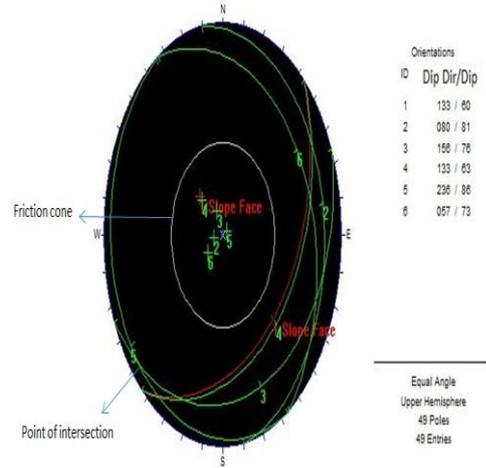
Figure 11: Wedge analysis for window 4

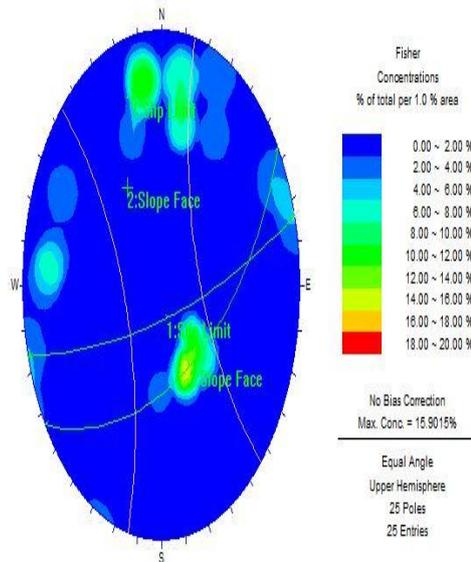
Figure 12: Toppling analysis for window 1

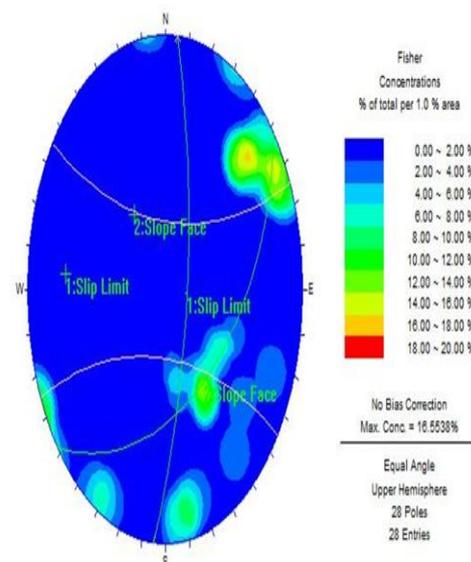
Figure 13: Toppling analysis for window 2

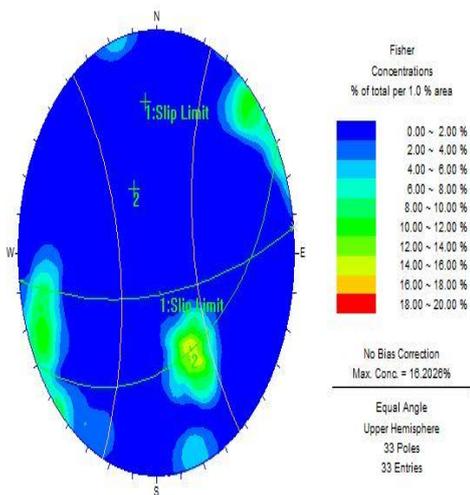
Figure 14: Toppling analysis for window 3

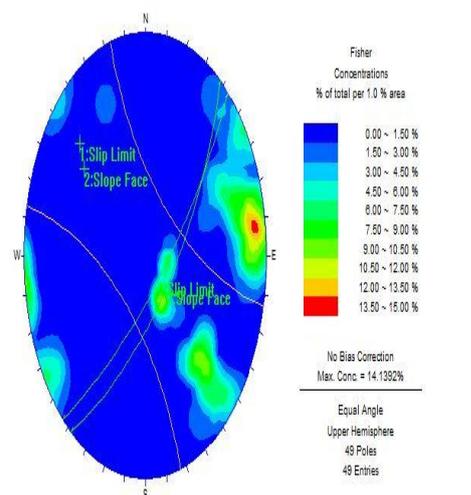
Figure 15: Toppling analysis for window 4
