Microstructural Characterization and Pits Morphology Analysis on Austenitic Stainless Steel Aisi 304

Abstract:- This paper aims to study the evolution establishing distribution and classification of pits in austenitic stainless steels AISI 304 obtained in state as received and heat-treated under different exposure times via Salt Spray. The work methodology started from the following steps: metallography preparation, corrosion tests via salt spray in different conditions, microstructural analysis, analysis of pits profiles, digital processing and images analysis for purposes of characterizing distribution, morphology and size of pits. In results obtained in digital processing and images analysis of profiles, the data were statistically analyzed using the median as evaluation parameter in the alloy as received and treated. The alloy, as received, exhibited the following morphology: hemispherical pits > transition region A > transition region B > irregular > conical. The pits amount in alloy treated in each exposure time is of the same order: transition region B > Hemispheric > transition region A > conical > irregular.

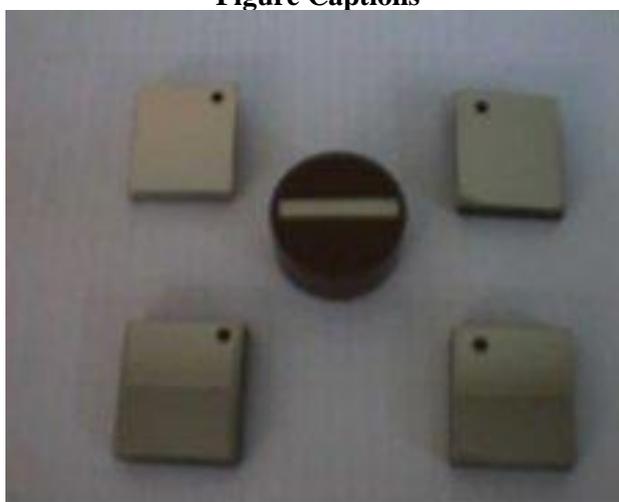
Fig. 1 – Specimens for corrosion testing.

The material used in this work is austenitic stainless steel AISI 304 provided in plate shape of 10 mm and 6 mm thick in as received state (rolled) and heat-treated at 620 ° C for 24 hours and cooled in air, as in figure 1.

The samples were made in dimensions 30mm x 25mm and superficially prepared (Figure 1). The corrosion tests were carried out via salt spray at the Central Laboratory of TEKNO SA unit Guaratinguetá. The samples were subjected to different exposure times such as 48, 120, 168, 216 and 312 hours.

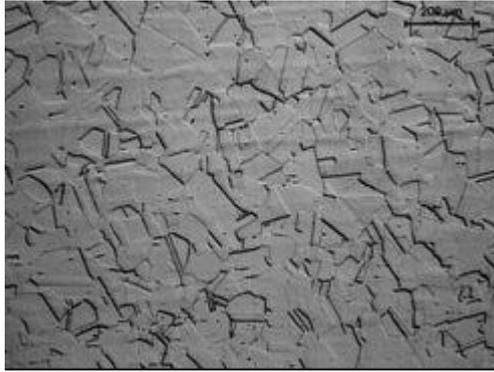
Fig. 2 - Micrograph of AISI 304 stainless steel as received, etched.

Figure 2 shows microstructure in the as received condition characterized by austenite grains typically in steps shape, and the sensitization level in this condition is estimated zero, it is observed presence of deformed regions and the microhardness values increase.

Pitting corrosion in as-received condition initiates at the grain boundaries and at the interface of mechanically deformed region such as twinned or steps in the grain boundaries. This contributes as a barrier, making difficult the whole mechanism of mass transport (pitting) and decreasing the growth kinetics of localized corrosion in the material, due to the typical microstructure as a step between the boundaries and zero sensitization (precipitation exemption of second phase).

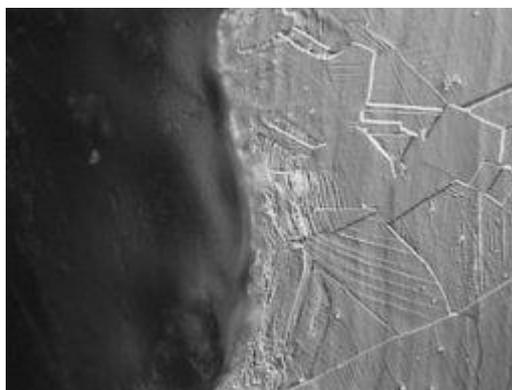
Fig. 4(a) - The occurrence of pitting corrosion on stainless steel 304 in the state as received.

Fig. 4(b) - Occurrence of pitting corrosion on stainless steel 304 in the state as received.

The micrographs 4 (a), (b) and 5 (a), (b) illustrate, from optical microscopy of profiles, different growth mechanisms of pits associated with microstructural features of alloy in the state received and treated, after being subjected to different exposure times in salt spray.
