A Study on Geo Hydrological And Qualitative Status of A Byramangala Lake

V. “A Study on Geo Hydrological And Qualitative Status of A Byramangala Lake .” International Journal Of Engineering Research And Development , vol. 13, no. 10, 2017, pp. 09–15.

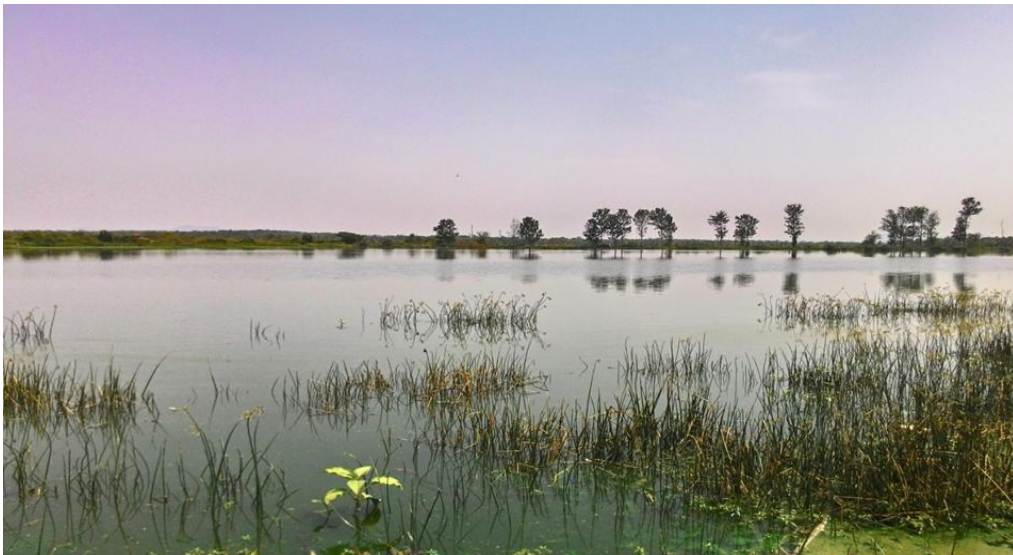
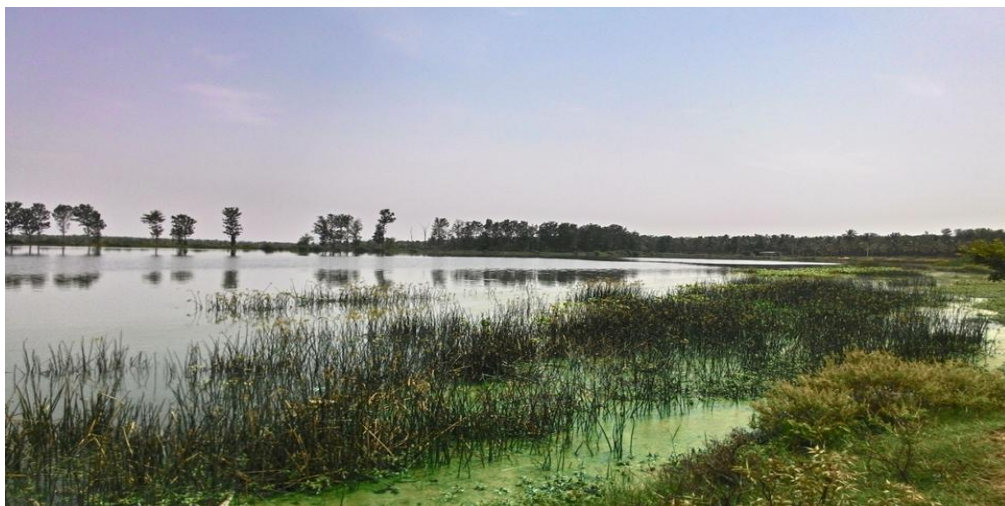
Fig5. Present Status of Lake
