Impact Study of Koottayi Regulator Cum Bridge

Abdul Hakkim V.M¹, Praveena N², Rakhi J. F³ and Ajay Gokul A.J⁴

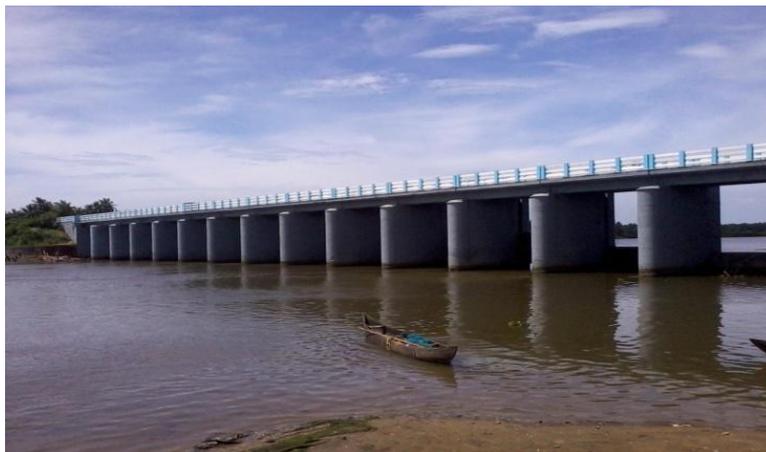
Fig. 1: Koottayi Regulator cum Bridge

The study was conducted in the areas of influence of Koottayi RCB in Malappuram District of Kerala. Water analysis and field survey were conducted for evaluating the effect of RCB on soil characteristic and water quality.
