Case Study on Water Ingress in Himalayan Tunnel

ABSTRACT

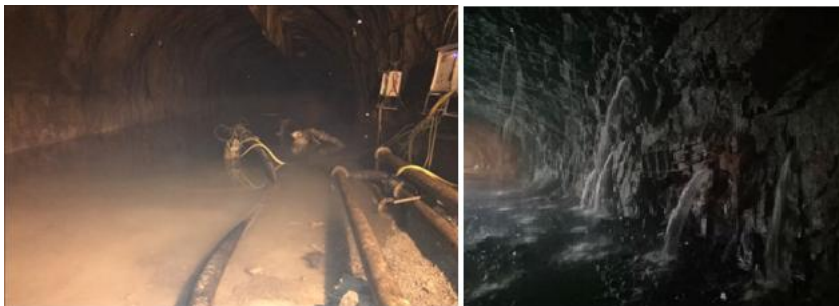
Figure 3: Tunnel flooding and water ingress

During excavation of the tunnel, first incidence of heavy water ingress with intensity 3300 - 5800 LPM was encountered from unexpected sources at RD 427.00m. All the tunneling works except dewatering had to be stopped. Heading excavation was resumed along with round the clock dewatering with 135 HP submersible pumps.

Again severe water ingress was encountered during heading excavation at RD 855.00m. The quantum of ingress of water was so huge that the tunnel rapidly got flooded up to RD 221.00. Since the exact location, geometry and ground water pressure head with which the water is inflowing could not be seen at this stage. The discharge could be assessed and was considered to be in the range of 21000 - 22000 LPM. The water ingress was once again encountered at RD 928.5m, leading to flooding of tunnel up to RD. 840m, estimating the discharge being 25000 – 26000 LPM.

Since, the tunnel was aligned in negative slope i.e. inlet level was higher than the outlet, the water could not be drained out by gravity. Therefore, the heading work halted till the dewatering could be done.

During first encounter of ingress at RD 427m, heading could be continued with the increased pumping system. However, next water ingress at RD. 855 was such a severe that existing arrangements of dewatering were not appropriate. This situation worsened due to reverse gradient and the tunnel got flooded up to RD 221m towards portal side resulting submergence of the existing pumping system near the face. Therefore, rest of pumps were shifted to the safer place. Further, a trench was excavated towards inlet portal side to tackle the untoward situation of water coming out of the portal and protection from any unprecedented situation of bank erosion.

The dewatering capacity was increased from 35 HP pump to 275 HP capacity and then 535 HP. Despite of large dewatering, the ingress of water could not be controlled to the desired extent, thereby acutely signifying the gravity of water.

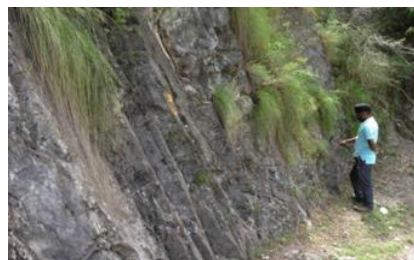
Figure 4: Geology in vicinity

In the project area, the river Chenab flows in a general NNE-SSW direction through a deep gorge. Two major tributaries with well-defined valleys, viz. Mandiyal nala and the Talsuen nala, join the Chenab River on left and right bank, respectively, immediately upstream of the tunnel alignment area. These two linear tributaries are strikingly opposite to each other and owe their origin to the major regional fault that runs along them in Himalayan Geology. The general orientation of these nalas is NW-SE. The mountains flanking the Chenab rise to heights over 900m, attaining elevations of 1400m and more. The river Chenab lies at an elevation of about 600m at Mandiyal confluence and at El ~550m below the tunnel west portal site.

The project area lies in Sirban Limestone represented mainly by dolomitic limestone with bands of dark grey to black slates. The sedimentary sequence of interbedded sandstone and shale belonging to Tertiary Murree Group lies immediately upstream of the tunnel alignment at a minimum distance of 425m. The contact between the Sirban Limestone and Murree Group is represented by a major regional fault. The rocks are profusely exposed on the valley faces and wherever covered the overburden of slope wash is believed to be thin.
