Padma River Bank Erosion in Naria, Shariatpur District, Bangladesh: Geomorphological, Geological, and Geotechnical Aspects

ABSTRACT The Naria Upazila of the Shariatpur district is situated on the right bank of the mighty Padma River, where extensive riverbank erosion has been occurring over the past several years. The purpose of the study is to decipher the geomorphological, geological, and engineering geological causes of bank erosion in the area. Conventional fieldwork was carried out in the area and systematic sample collection was done. Standard laboratory processes were followed to analyze the samples. The aerial photographs and Google images study indicate that the Tippera alluvial sediments of the Mid-Holocene age are less eroded than the active bar and floodplain deposits of recent age. This may be owing to the moderately compacted older sediments of the Tippera deposits, whose *N* values also reflect dense sediment packing. Other geotechnical features like grain size distributions, type, plasticity index, friction angle, and relative shear strength confirm similar results as well. Though the results of the study show that sediment qualities have an impact on erosion the s

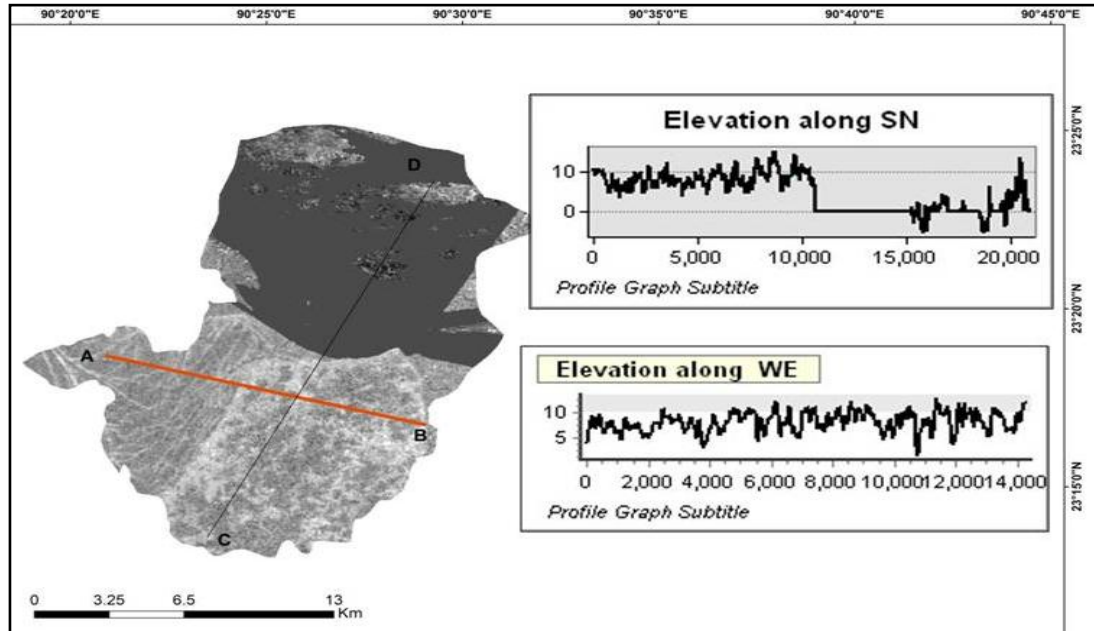
Figure 2. Elevation profile along SN and WE derived from the SRTM (Shuttle radar topographic mission)

By studying the aerial photographs of 1954, four types of geomorphological units are identified which were verified during the fieldwork. The units are-Tipper surface/ Chandina Deltaic plain, Flood Plain, Lateral Bar, and Active Channel. The studied area is situated on the south bank of the Padma River flowing from north to south. Drainage density is low in the mapped area. Palong and Kiritinasha are the small distributaries of the Padma. From the SRTM image and profilings, it is obvious that the western and eastern part of the mapped area is younger than the middle part. The middle part is comprised of the Tippera surface whereas the western part is the floodplain and the eastern part is the bar. Elevation varies with different geomorphic units (Fig.2). Elevation variation (6m -8m) is low and the slope is very gentle.

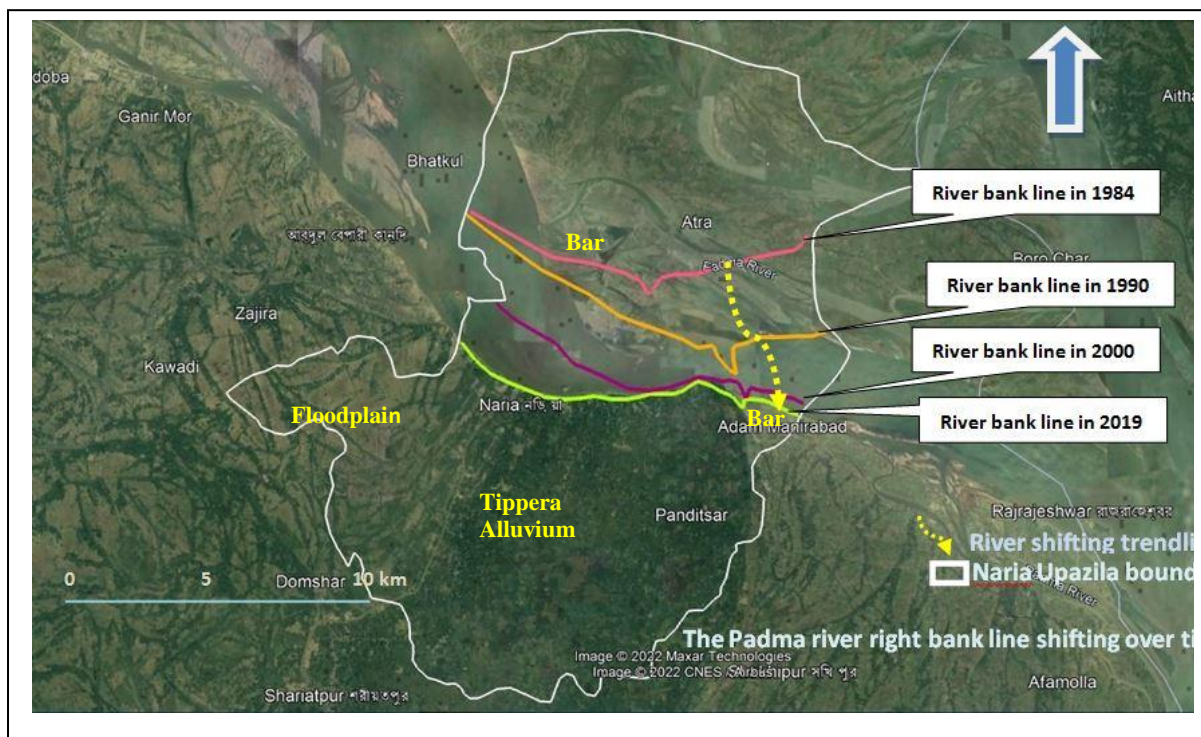
Figure 3. River bank Erosion curvature is higher in the Younger floodplain than in the Mid- Holocene Chandina alluvium. Chanidina Alluvium is about 1m high than the surroundings.

To assess the bank line movement or change in shifting, four Google images of 1984, 1990, 2000 & 2019 during the dry season are analyzed. As a typical alluvial river, the River experienced frequent morphological changes. The same holds for the Padma river in the research area. With its morphologically dynamic nature, the Padma River near Naria underwent significant alterations in its right banks and the creation of bars in the left banks from 1984 to 2019. The results of the bank line movement of the river indicate that the right banks of the Padma have changed significantly due to varying erosion and accretion. i.e, channel bar and lateral bar formation on other sides. Erosion curvature is higher in flood plain than on the Tippera surface (Fig. 3).

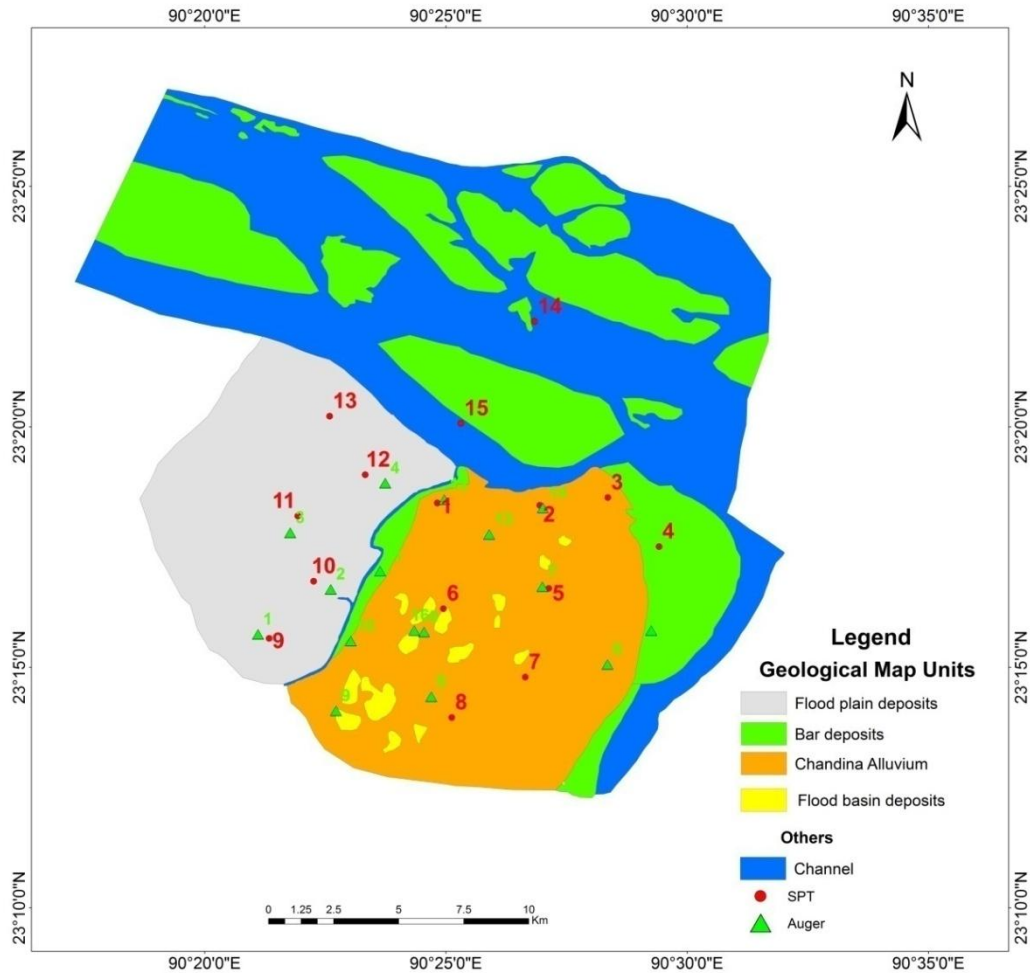
Figure 4. Geological Map of the Naria Upazila and its surroundings

Surface and subsurface geological data were calculated from the Auger and SPT borehole data. Data shows that the study area is mainly composed of Chandina Alluvial/Tippera deposits, Floodplain deposits, and Bar deposits (Fig.4). Sedimentary and lithologic characteristics are discussed below-

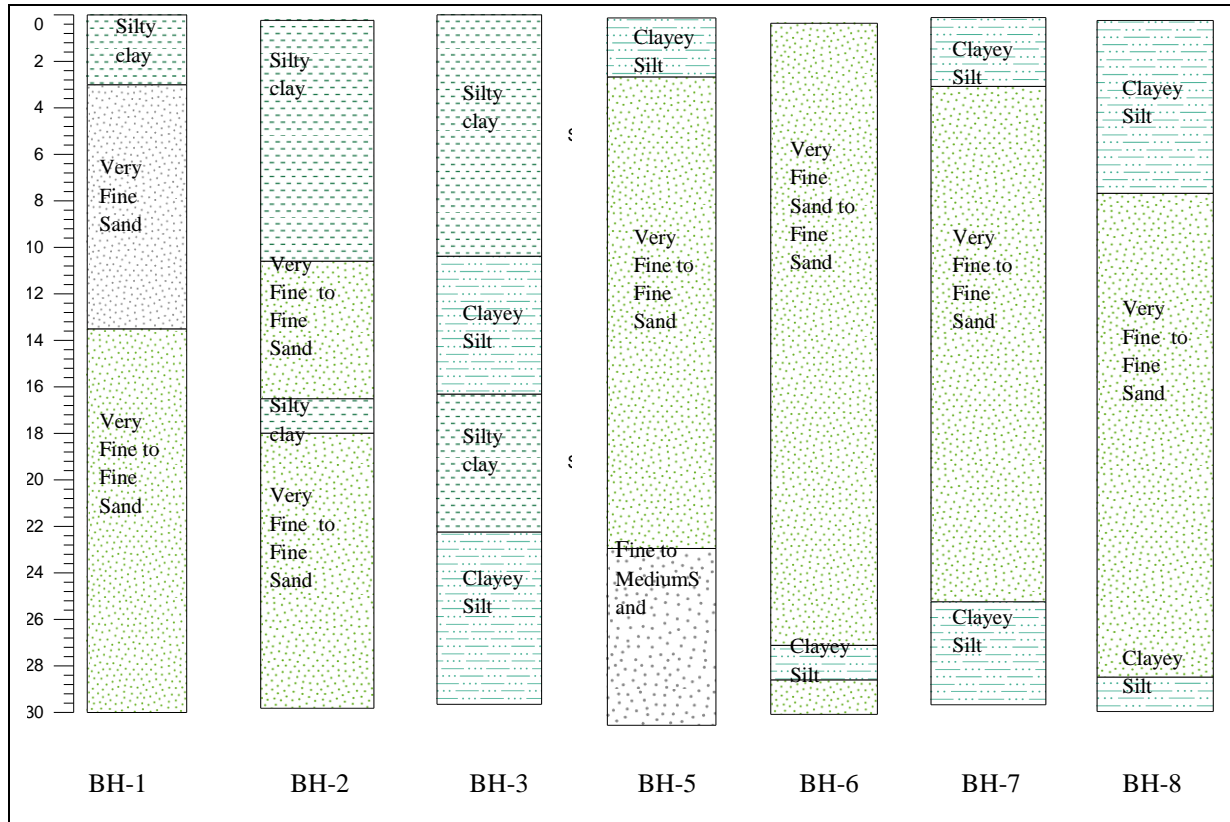
Figure 6. SPT Bore holes data on Tippera / Chandina alluvial deposits,

The sediment sample collected from the SPT borehole suggests that the upper 5 to 7m consists of mainly yellowish brown and light gray silty clay, medium gray clayey silt, and the lower part mainly consists of light olive gray colored very fine to fine sands and greenish gray colored fine to medium sand. Sands are thinly laminated. The sediments are moderately compacted in hand specimens (Fig.5a, 5b & 6).

In Chandina alluvium, SPT-N values range from 3 to 30 up to a depth of 20 m depth and increase up to 80 with increasing depth. Whereas in the flood plain deposits N value ranges from 1 to 20 in the upper 20 m depth and increases up to 45 with depth and on bar deposits N values are calculated from 1 to 12 up to the first 20 m depth and increase up to 25. According to Meyerhof, 1956 (Table 1), the sediments of Chandina Alluvial deposits are compact to very dense, floodplain sediments show compact to dense, and bar sediments are very loose to compact soil packing in nature.

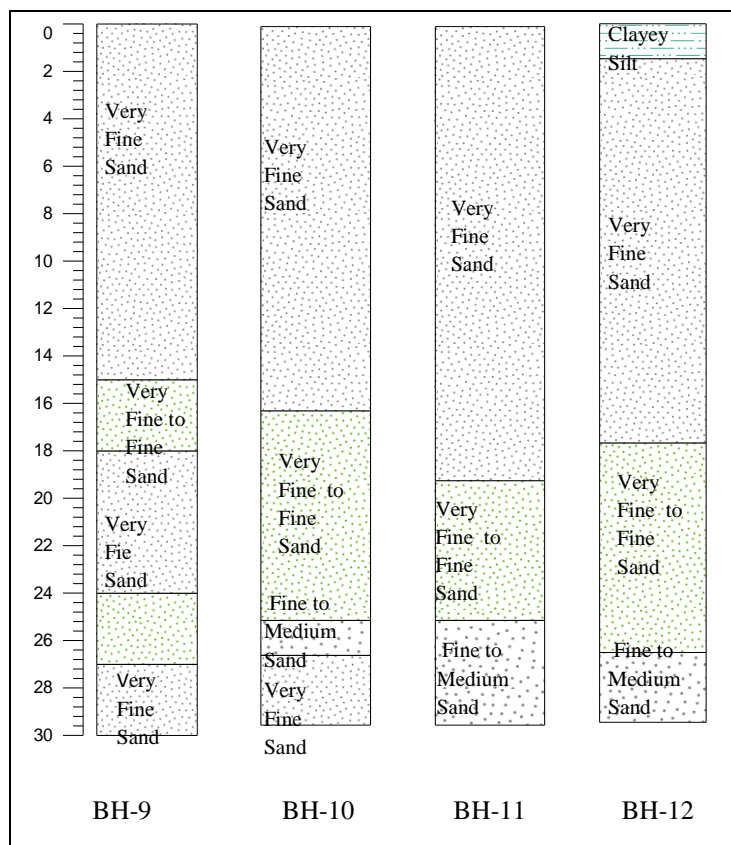
Figure 7. SPT Bore holes data on Flood plain deposits

Shallow borehole data from the southern part of the flood plain reveal that the deposits consist of light olive gray and greenish gray silty clay, greenish very fine silty sand. Undisturbed samples from the SPT borehole explicit that the upper 25.5m of the deposits consists of greenish gray colored very fine to fine sand, greenish gray colored fine to medium sand, and medium-grained gray clayey silt (Fig 7).

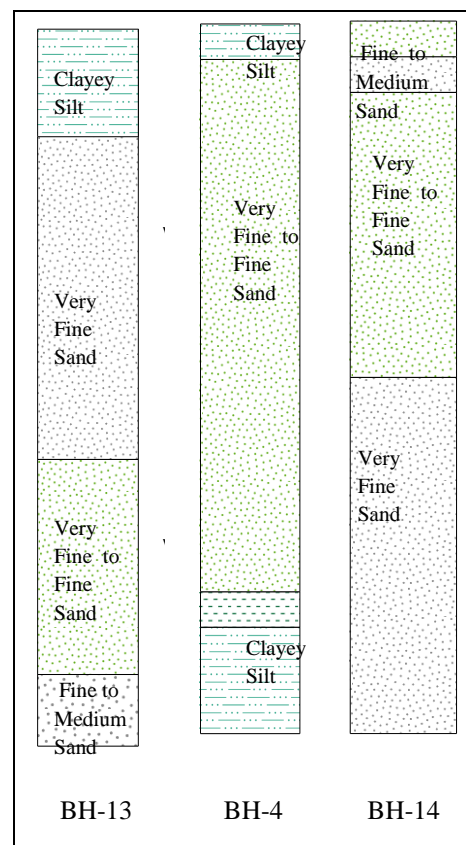
Figure 8. SPT Bore holes data on Bar deposits

The Channel bar deposit comprises mainly light greenish gray very fine to fine sands, fine sands with some silty clay, and fine to medium sands. Sediments are very loosely consolidated (Fig. 8).
