# **Landslide Remediation in Save Skarica Street, Sarajevo – A Case Study**

Selma Neković

*<sup>1</sup>Department of Civil Engineering, Faculty of Engineering, Natural and Medical Sciences  
International Burch University, Sarajevo, Bosnia and Herzegovina*

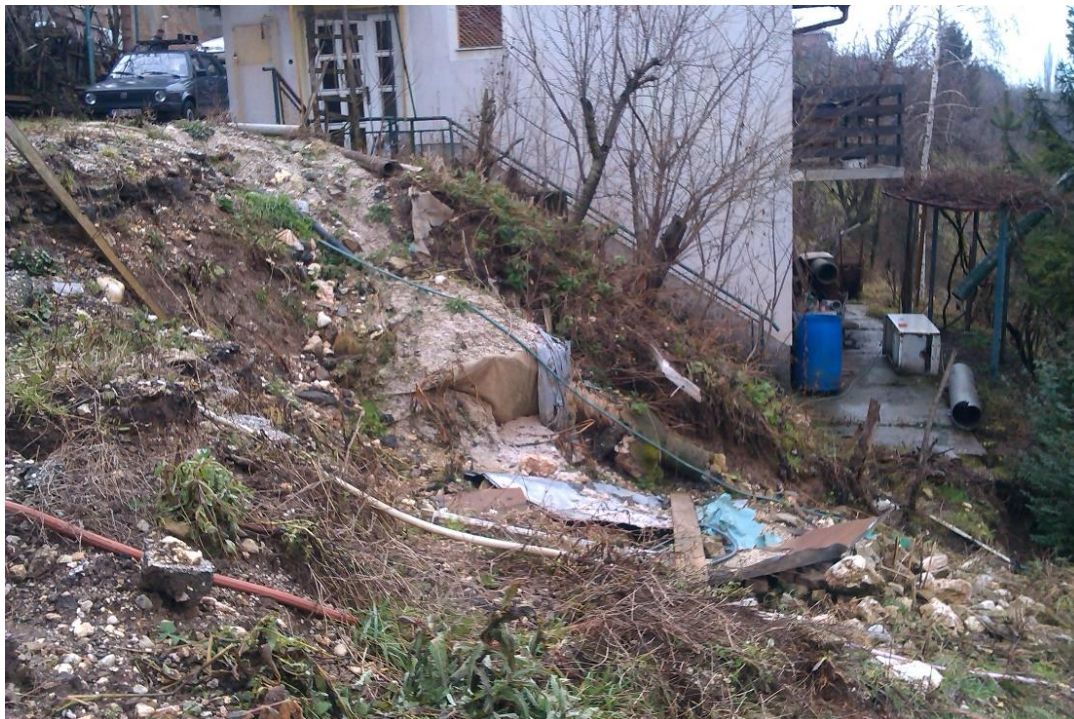
**Figure 1. Part of the slope and developed area at the site (from the design documentation).**

The investigated site is located on the northern slopes of Mount Trebević, descending toward the Miljacka River valley. The morphology of the wider area is irregular, and the present-day relief has been influenced by erosion-denudation processes as well as by downslope movements of soil material [1]. At the site itself, the steep slope and existing development further limit the possibility of simple terrain reshaping.

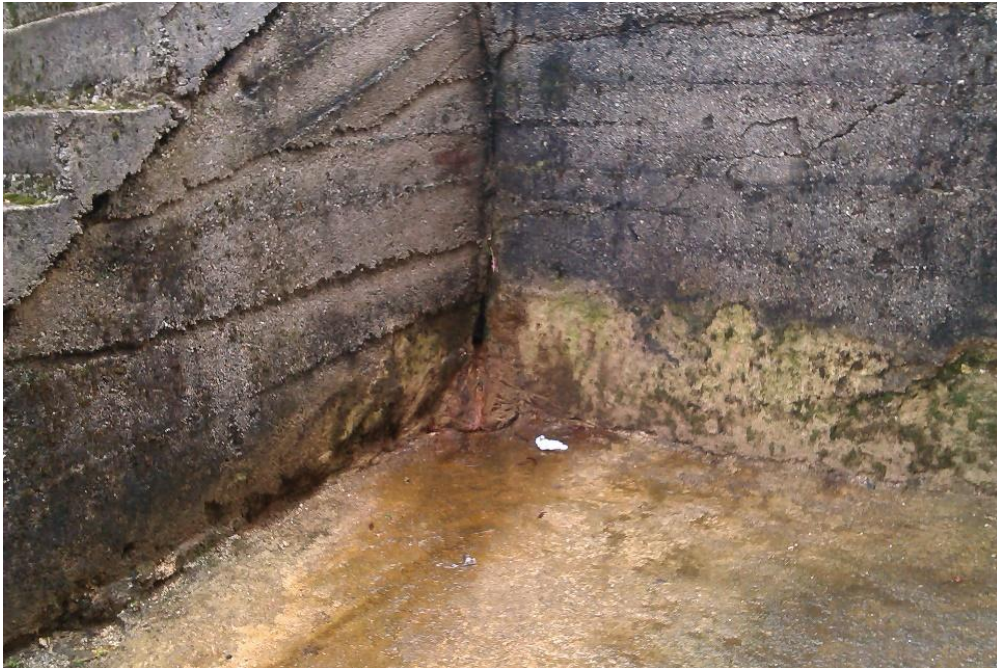
**Figure 2. Water observed adjacent to an existing structure at the site (from the design documentation).**

approximately 4.0 m [1]. The design documentation also records water at the ground surface and continuous flow down the slope [2]. These observations indicate that hydrological conditions may vary locally and over time, particularly near the inadequately collected culvert discharge.

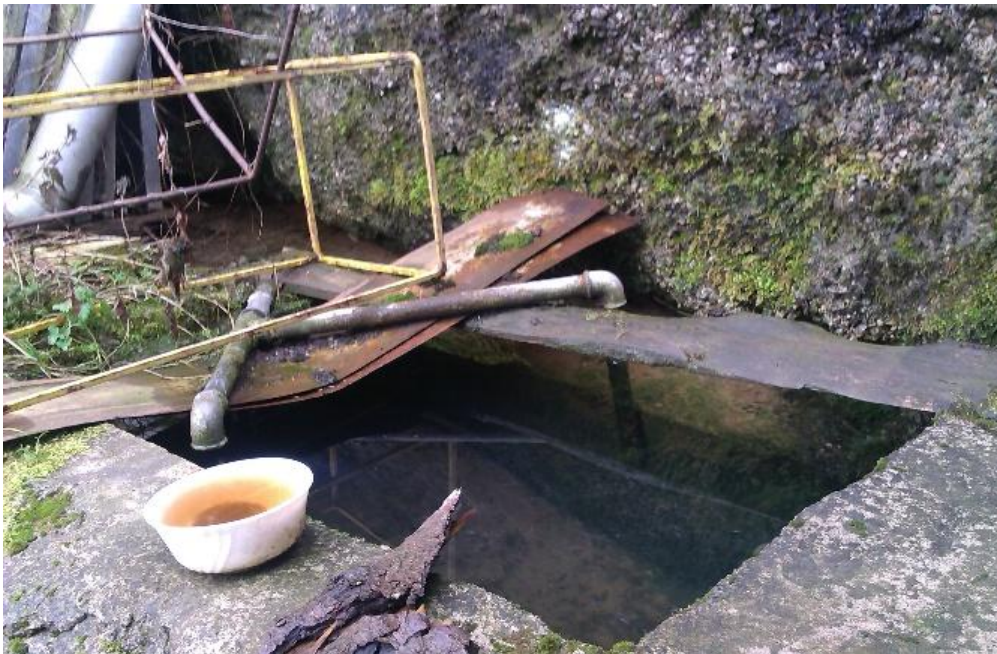
**Figure 3. Local drainage/water system element at the site (from the design documentation).**

The design adopts a combined solution addressing both the cause and the consequences of instability. The first group of measures concerns water management: the existing culvert discharge is collected in an inspection chamber and conveyed through collector pipes to the receiving outlet; the RO2–RO3 drainage line and drainage behind the retaining wall are also provided. The second group comprises structural measures: a reinforced-concrete L-shaped wall, 24.90 m long and 2.0 m high, with a 2.0 m wide footing and a footing and stem thickness of 0.40 m, is constructed. The wall is supported by  $\Phi 300$  mm piles at 5.0 m spacing. Each pile pair consists of one vertical pile and one inclined pile at  $20^\circ$  from the vertical, with lengths of 8.0 m and 10.0 m [2].

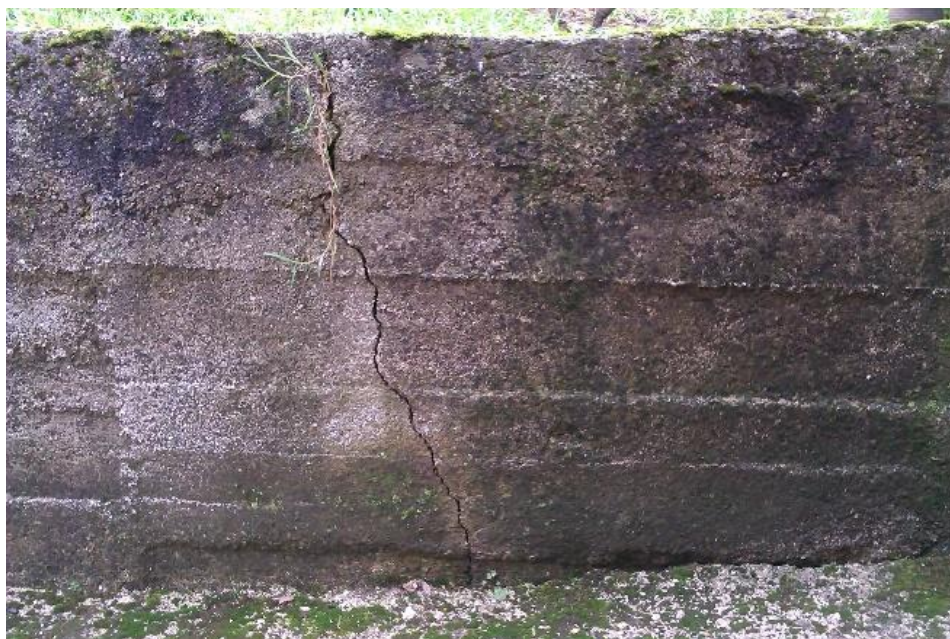
Figure 6. Cracks and damage to the existing retaining wall (from the design documentation).

The results of field observations and investigations indicate a combined hydrogeological-geotechnical mechanism. Sliding occurs within the clayey cover of poorer geotechnical properties above the more competent Miocene substratum. The inadequately managed culvert caused water to spread over the slope and locally saturate the cover. Increased moisture content and pore-water pressure reduced the effective stress and available shear resistance, while the steep slope inclination represented an additional adverse factor. The resulting effects were deformations and cracks in walls, buildings, and the access road [1,2].
